**National
Transportation
Safety Board**

Helicopter Case Studies

Case Study 1

- MD Helicopters 369D
- One Rolls-Royce 250-C20B
- Near Oso, WA
- July 22, 2014
- Injuries: 1 serious
- NTSB Case No. WPR14LA308

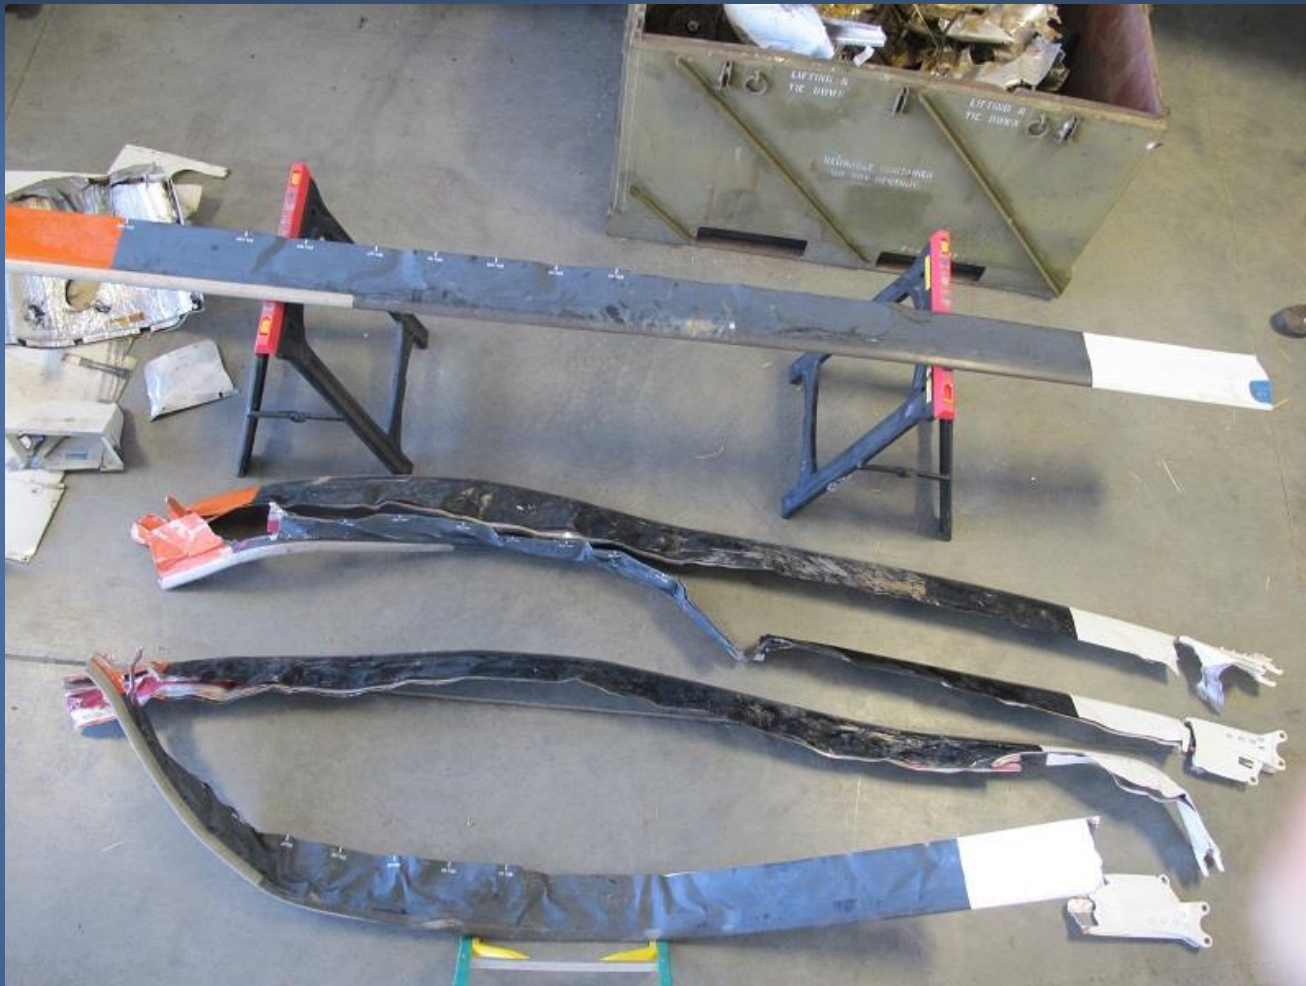
Recovered Main Rotor Blades

- On July 22, 2014, about 1120 PDT, a MD Helicopters 369D collided with terrain and rolled downhill.
- Part 133 external load operation moving cut trees.
- One of the five main rotor blades found about 900 feet away.

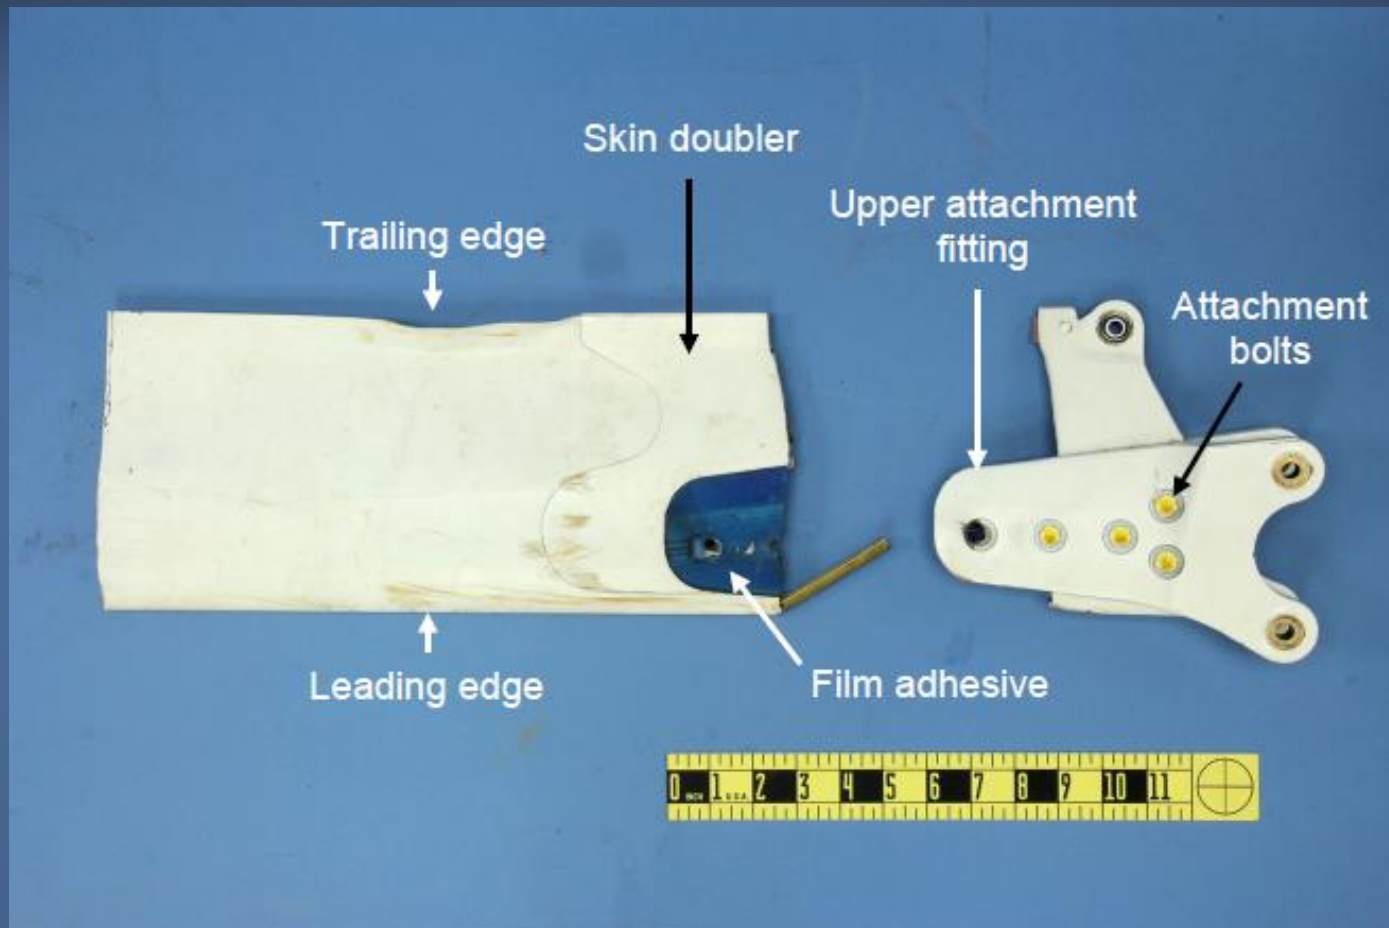
- Discovered fatigue fracture initiation at outboard attachment fitting holes (both upper and lower sides) of the spar.
- Tertiary fatigue initiation at spar leading edge.
- Evidence of disbonding between fitting and blade airfoil.

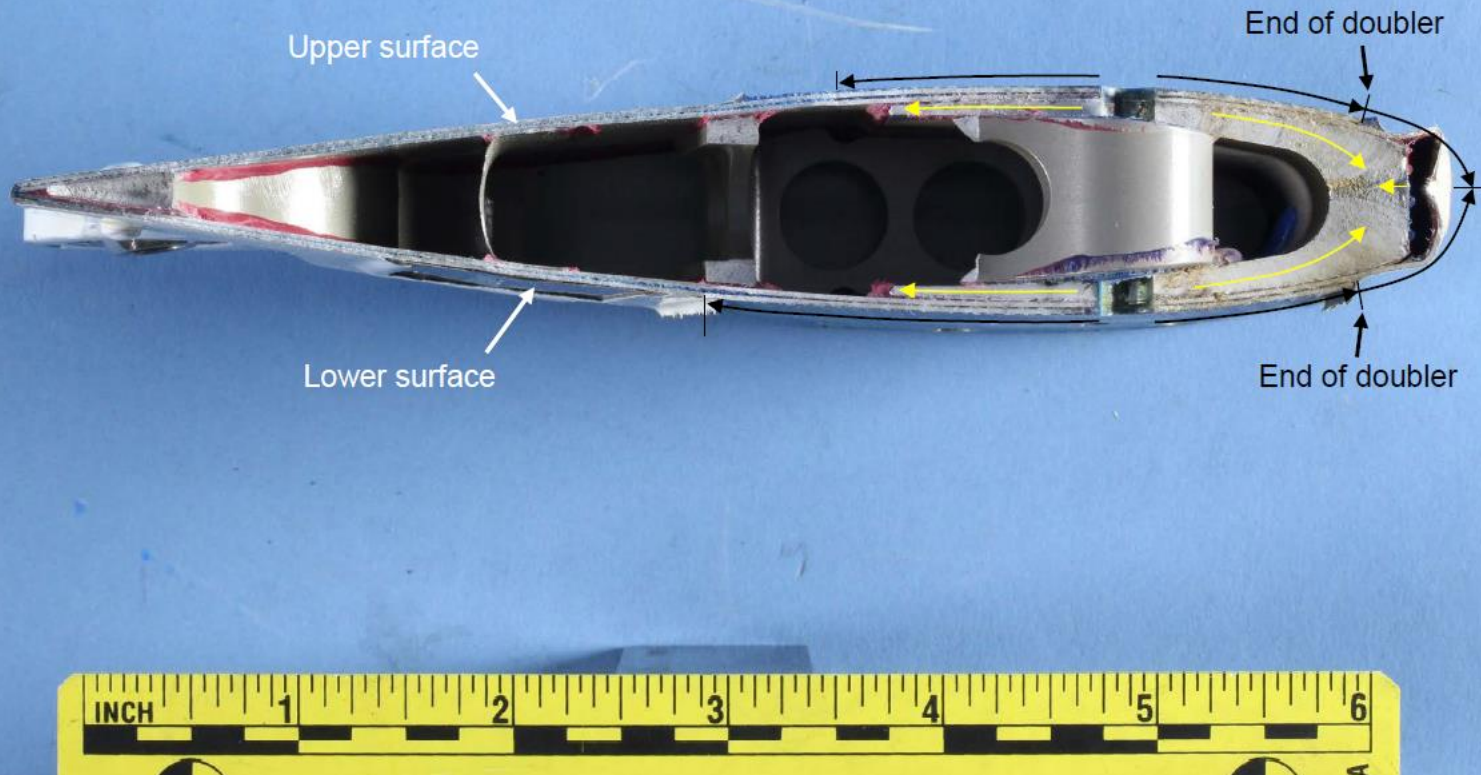
→ = Spar fatigue fracture path

→ = Skin and doubler fatigue fracture path

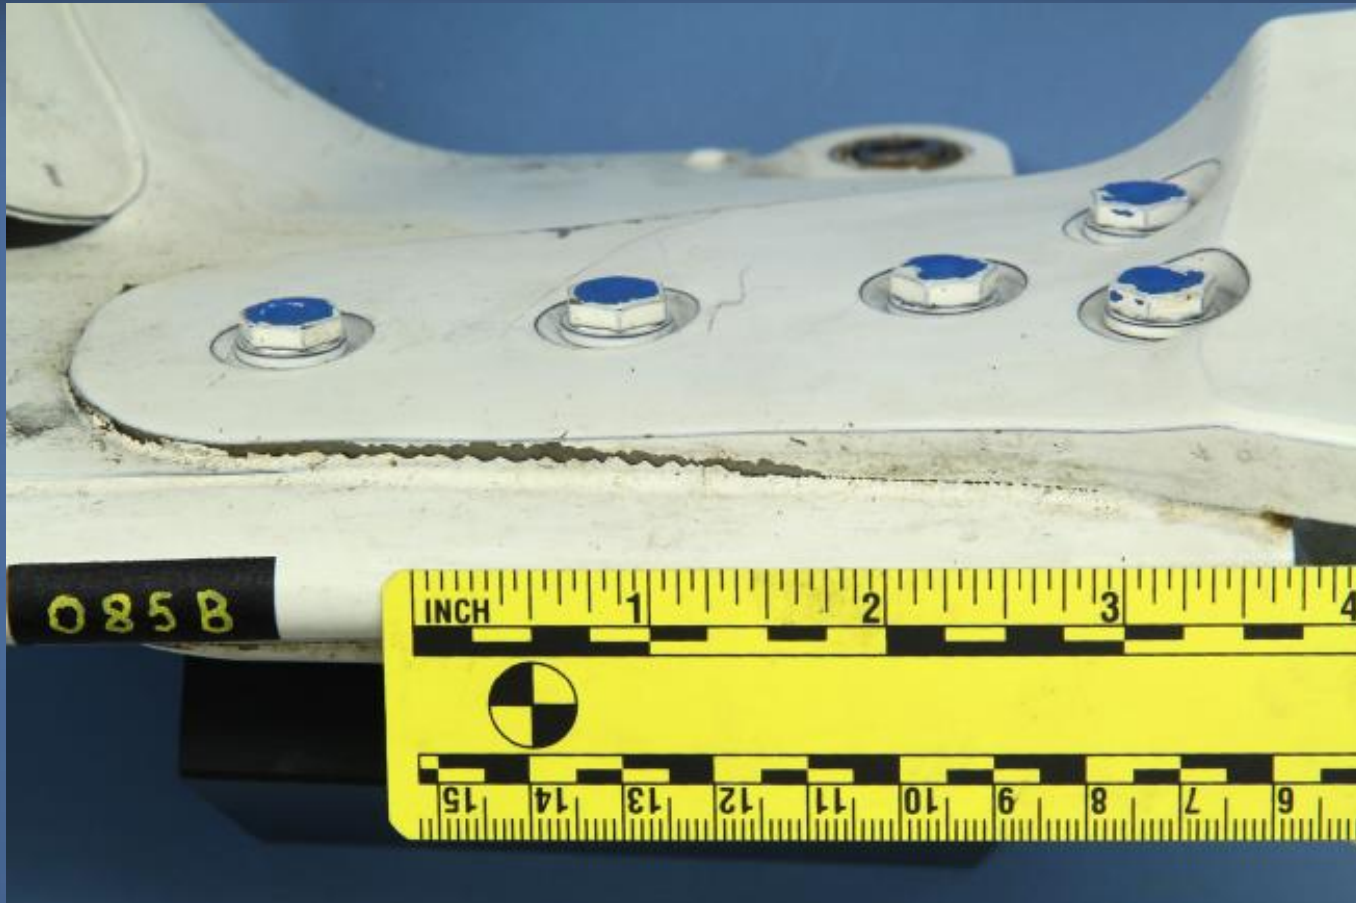
- On one of the four remaining blades, found evidence of paint cracking around attaching fitting edges.
- Removal of fitting attachment bolts revealed disbonding between fitting and blade airfoil.

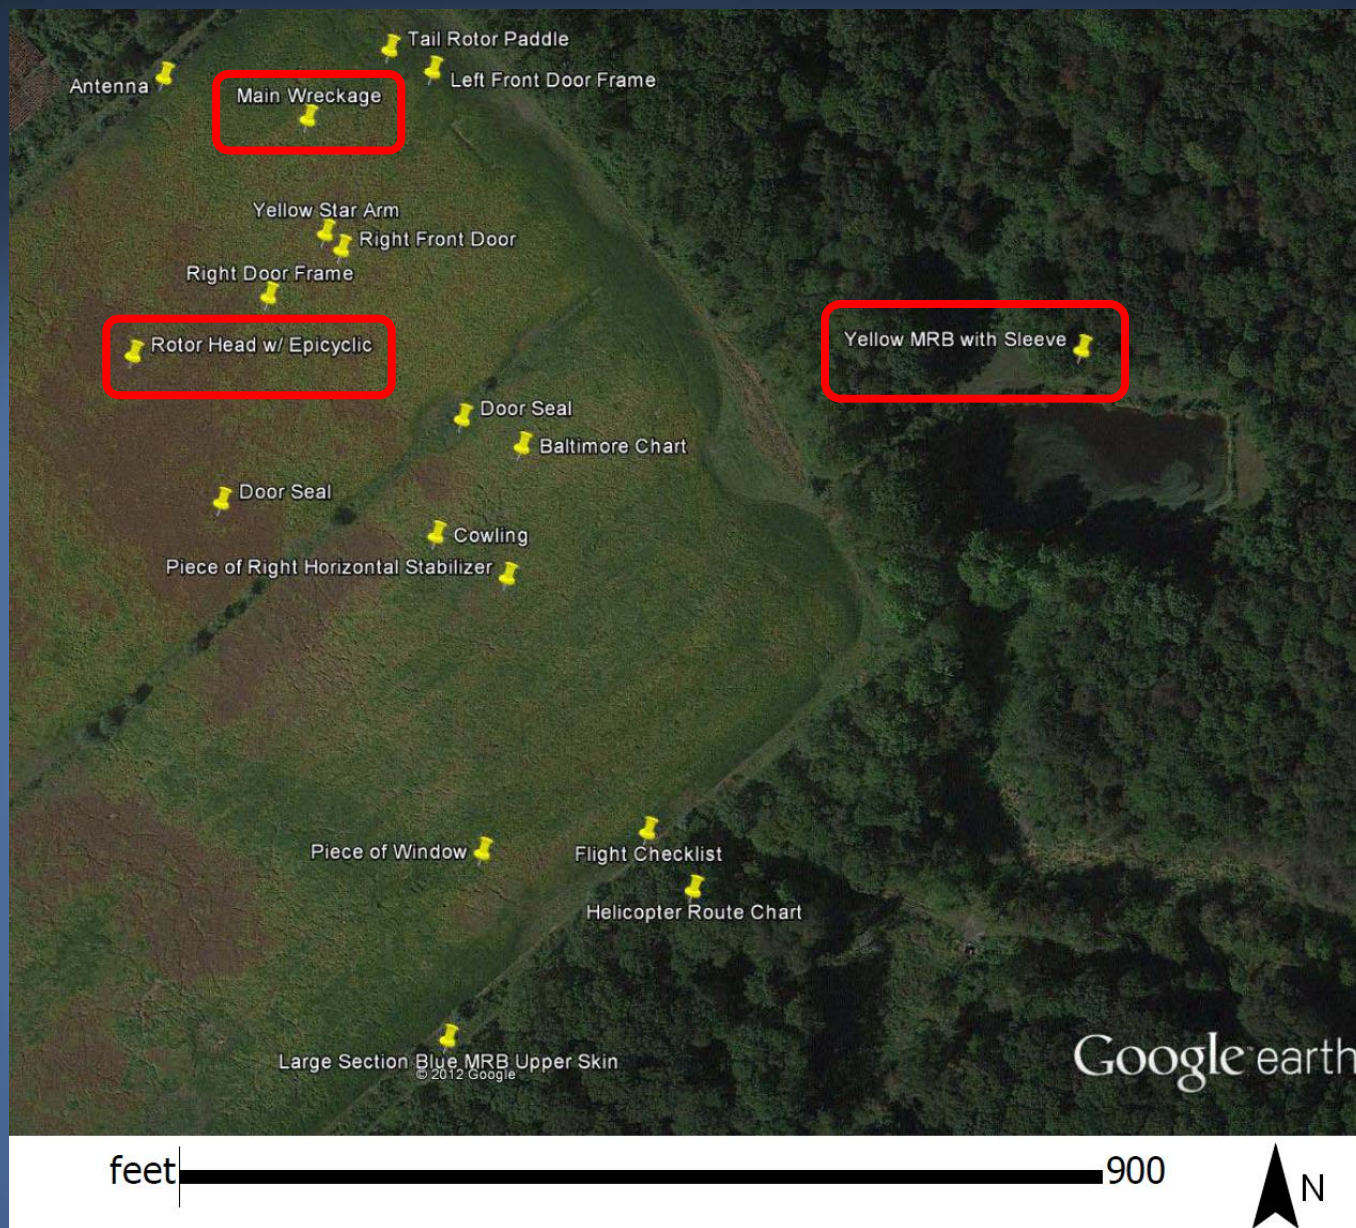
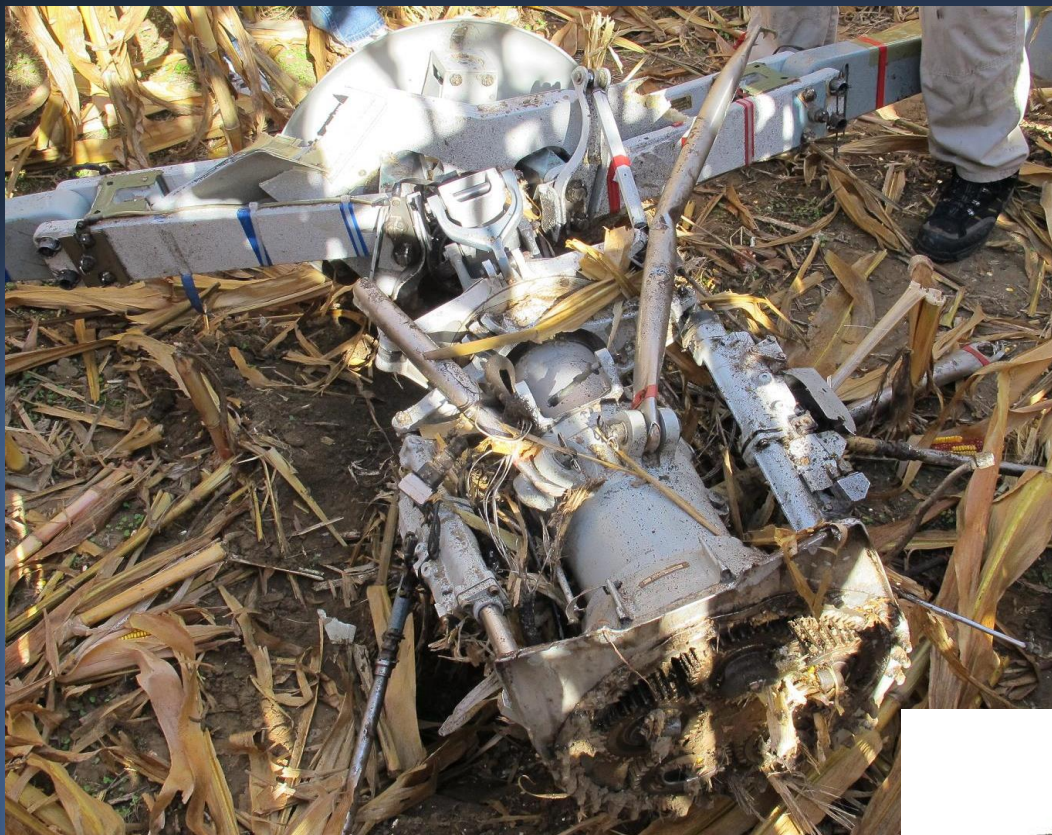
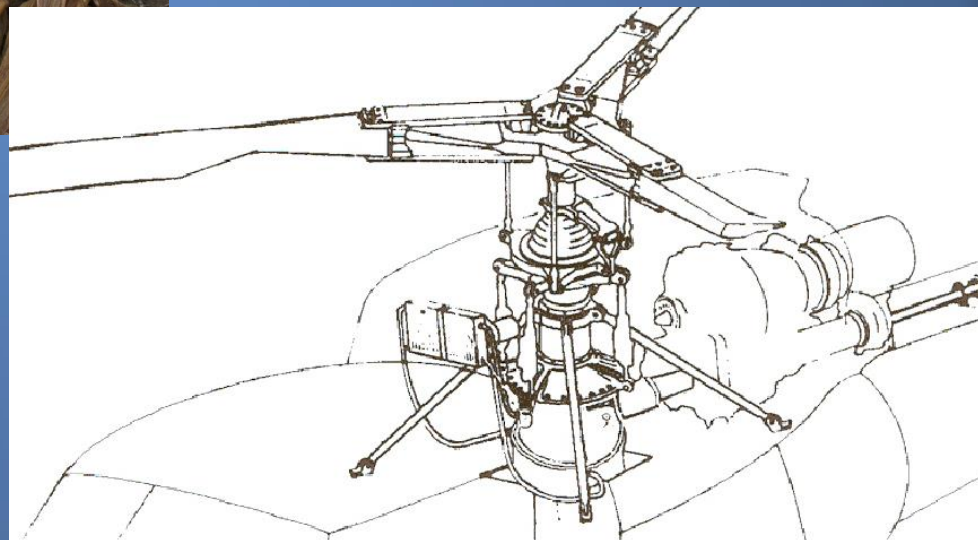
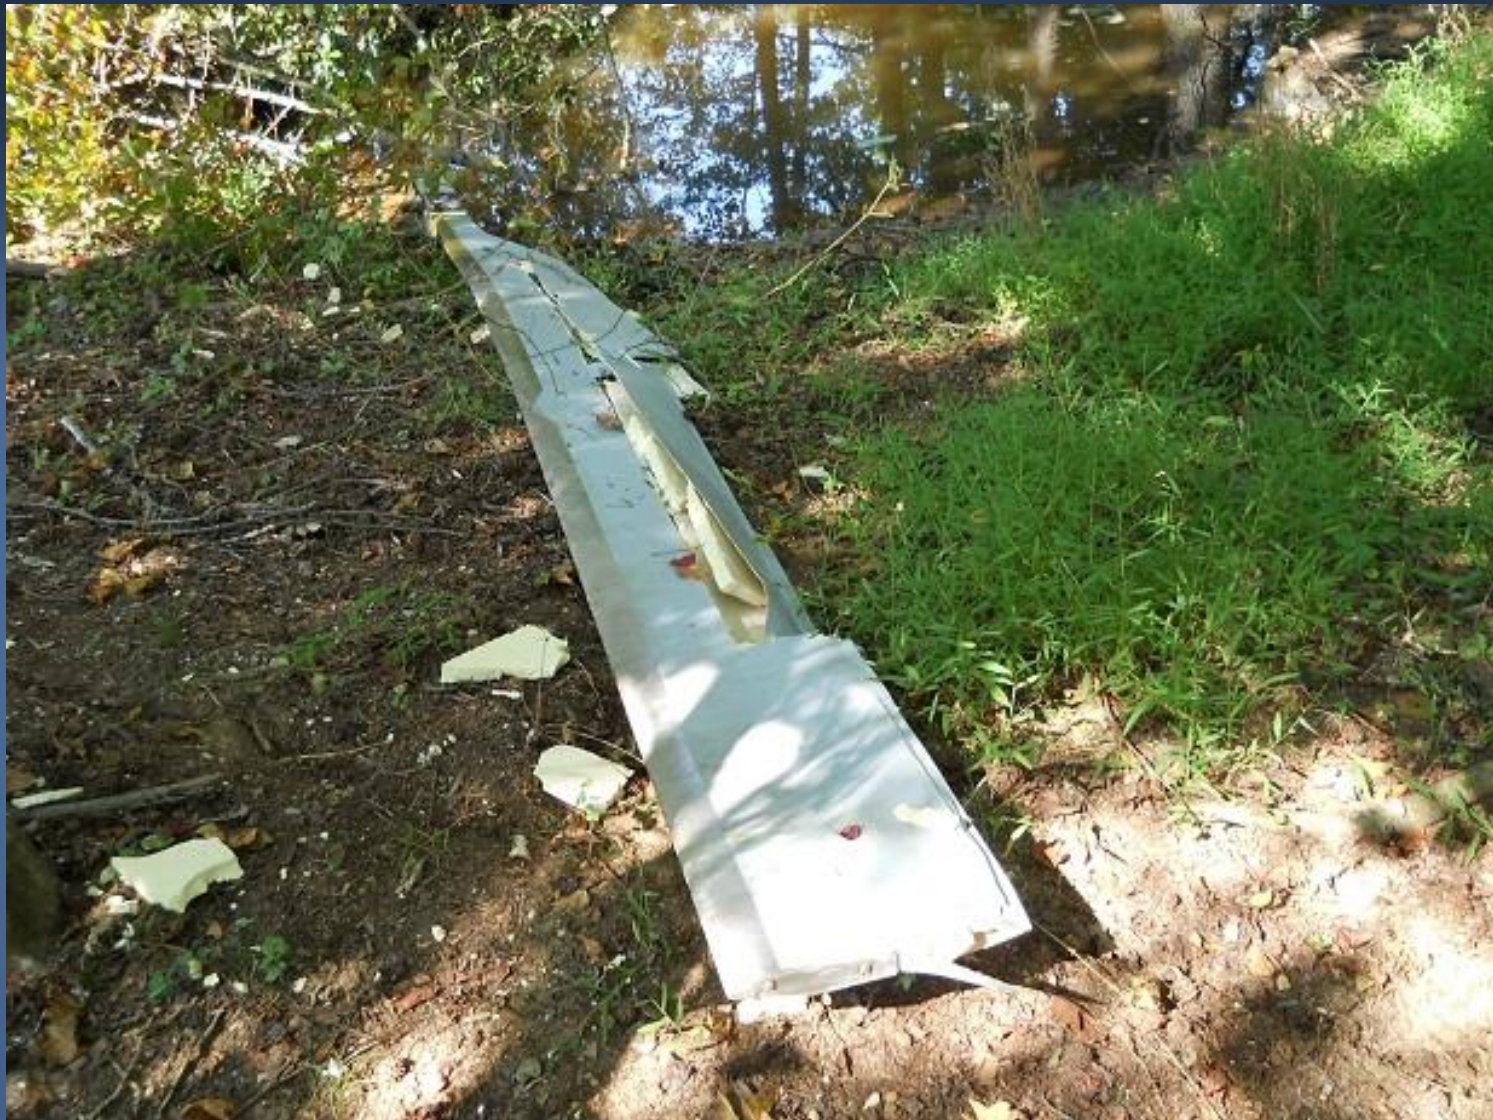
- The upper portion of the main transmission, main rotor mast and head, and two of three main rotor blades were found about 100 yards SW away from the main wreckage.
- The third main rotor blade was found about 270 yards ESE of the main wreckage.

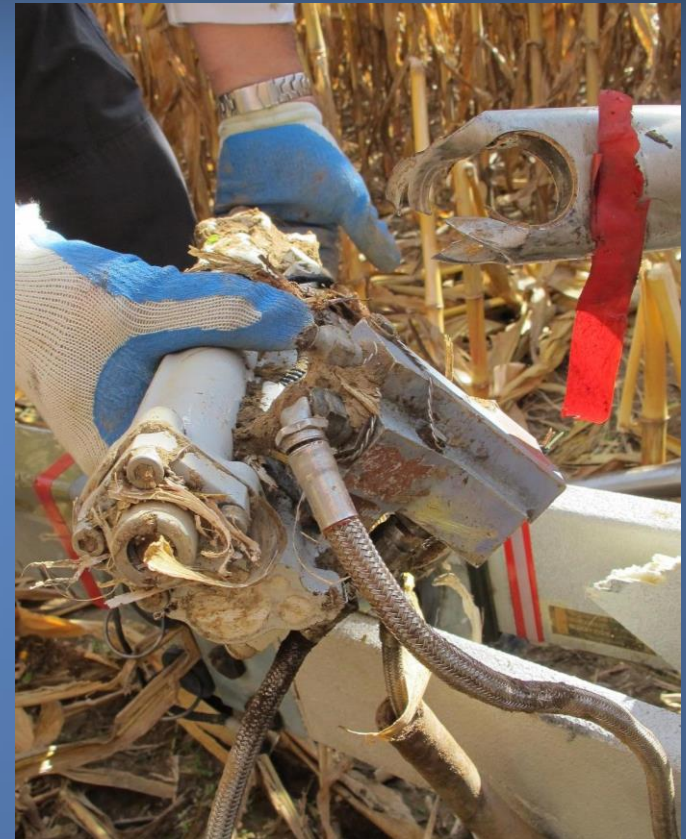
- The left-roll and right-roll servo controls remained attached to the main transmission and swashplate.
- The fore-aft servo control was found separated.

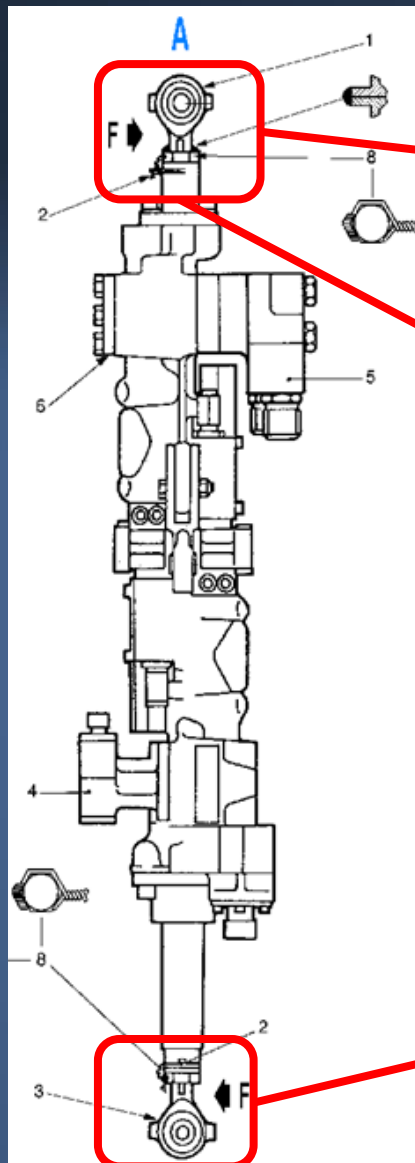
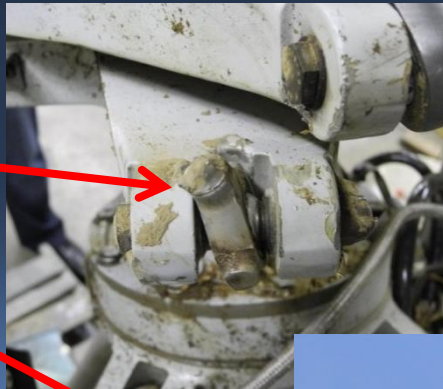
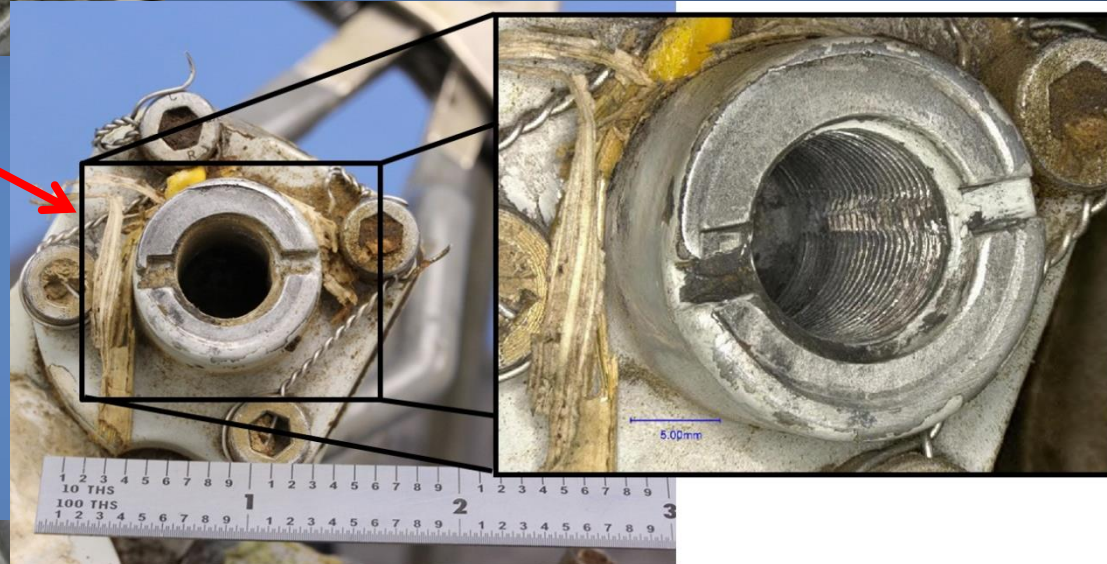
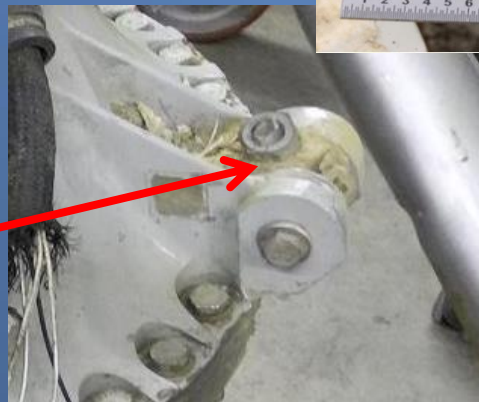
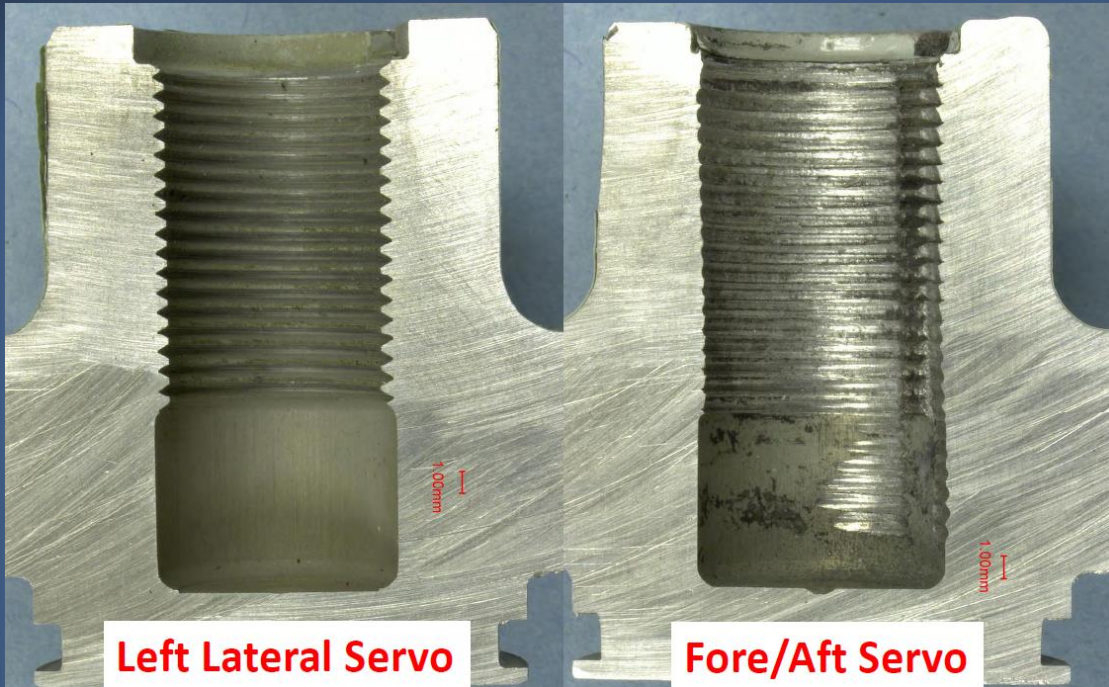
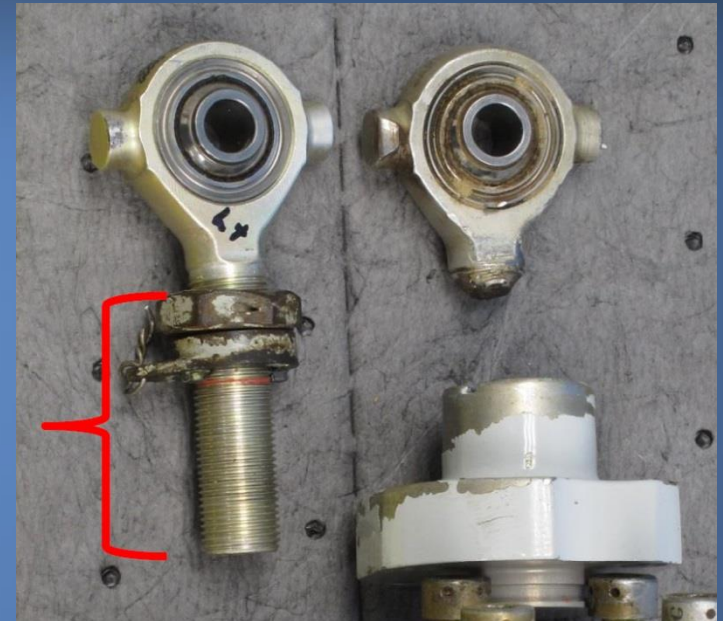
- The fore-aft servo control threads which mate to the upper rod end were found to be severely worn.
 - Consistent with wear over time versus upper rod end being pulled out during ground impact.
- Upper rod end threaded shank had fractured and was not recovered.

- Disconnection of the upper rod end from the fore/aft servo due to severely worn threads, which resulted in a loss of control and separation of a main rotor blade during cruise flight. Contributing to the accident were incorrect maintenance procedures and inadequate maintenance inspections performed by the operator, and insufficient inspection criteria provided by the helicopter manufacturer.

- Airframe manufacturer released a safety information notice regarding the accident findings and recurring visual and tactile inspections of the joint.

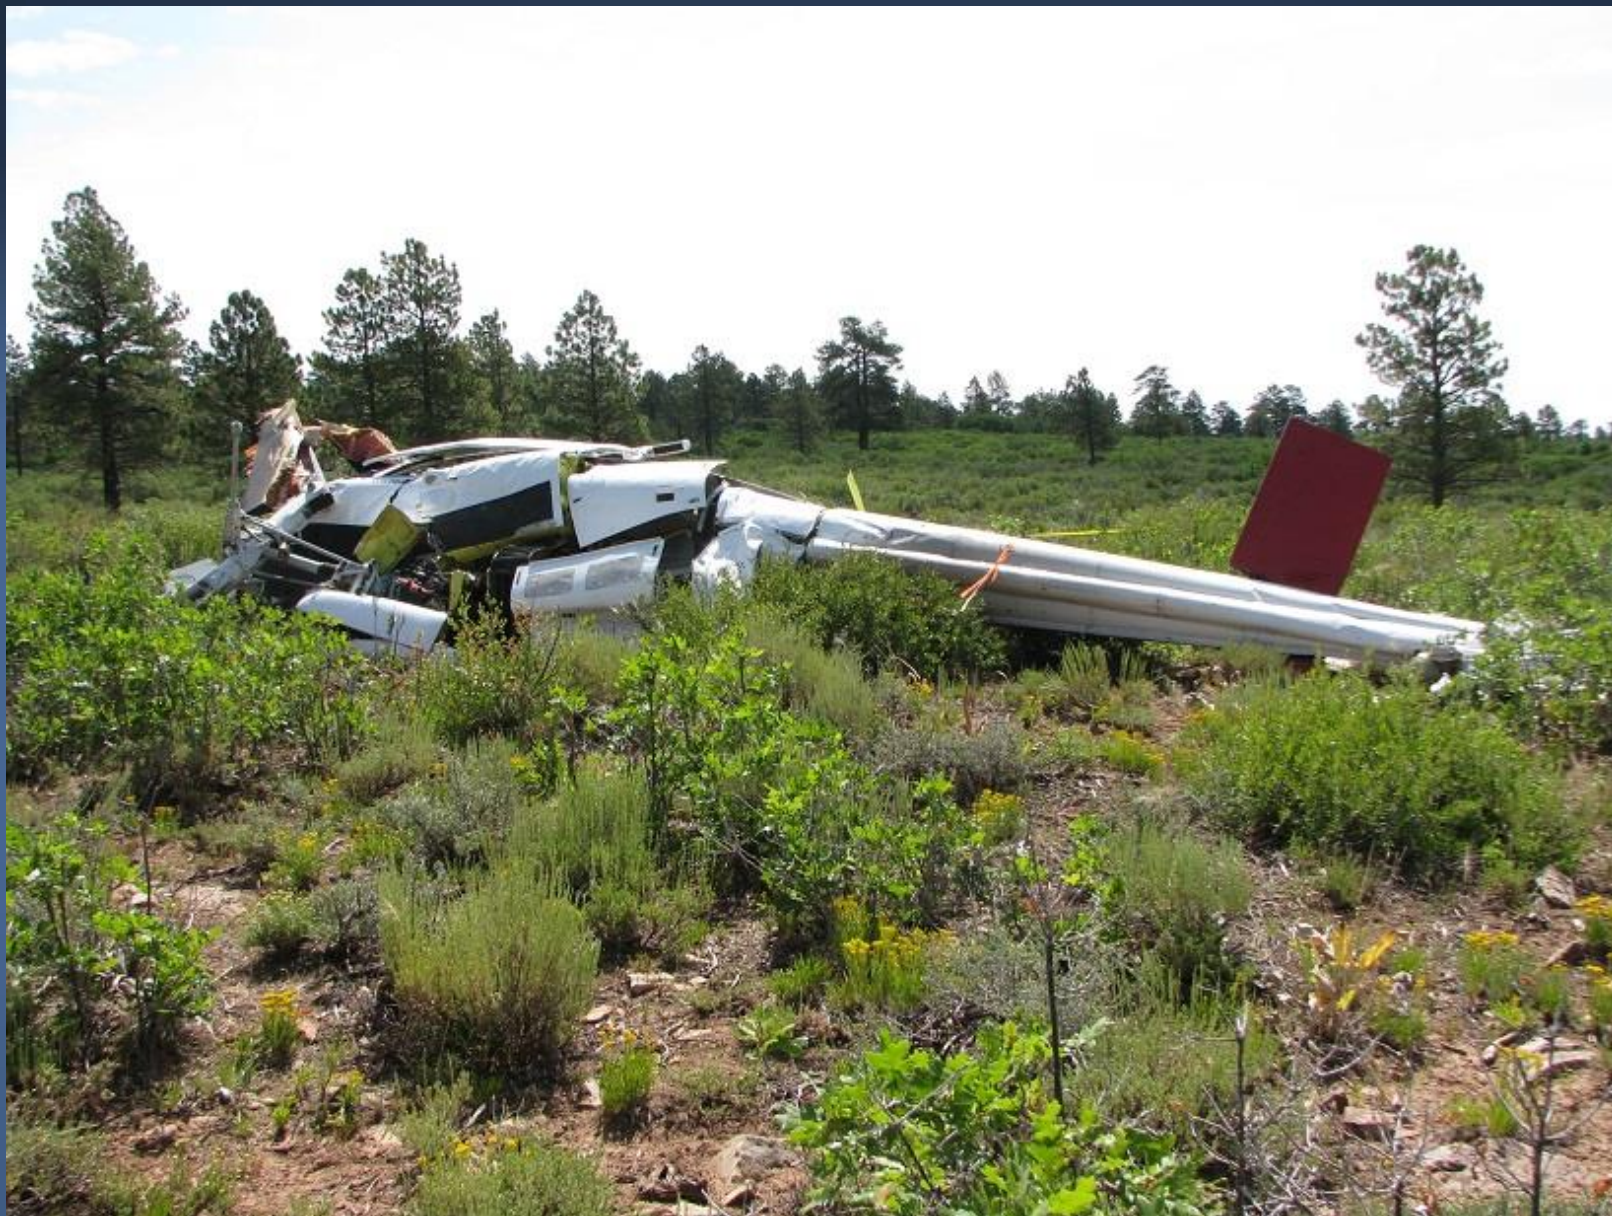
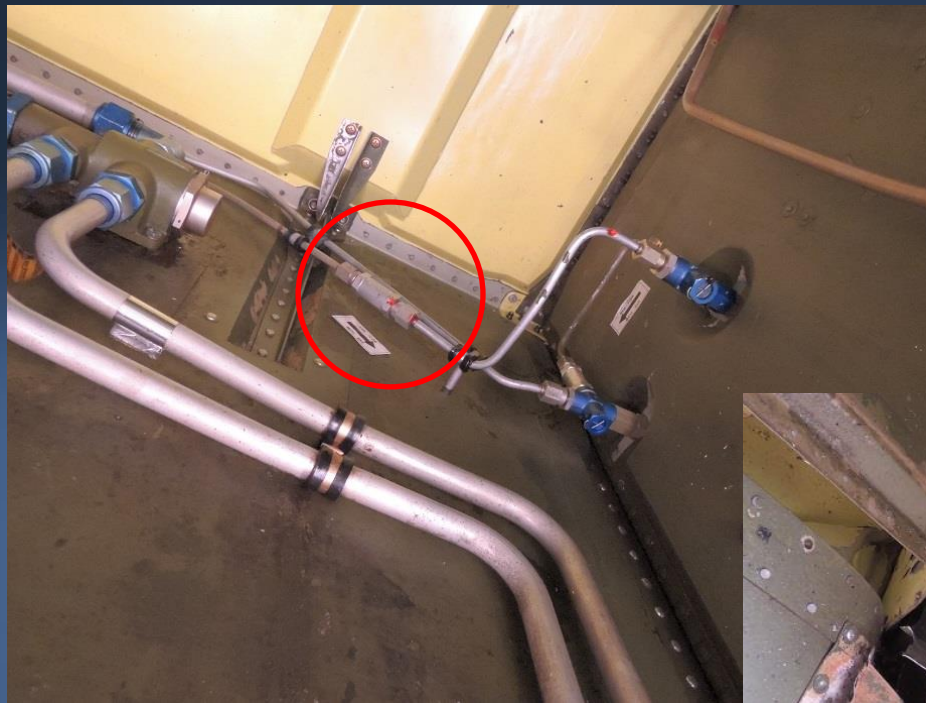
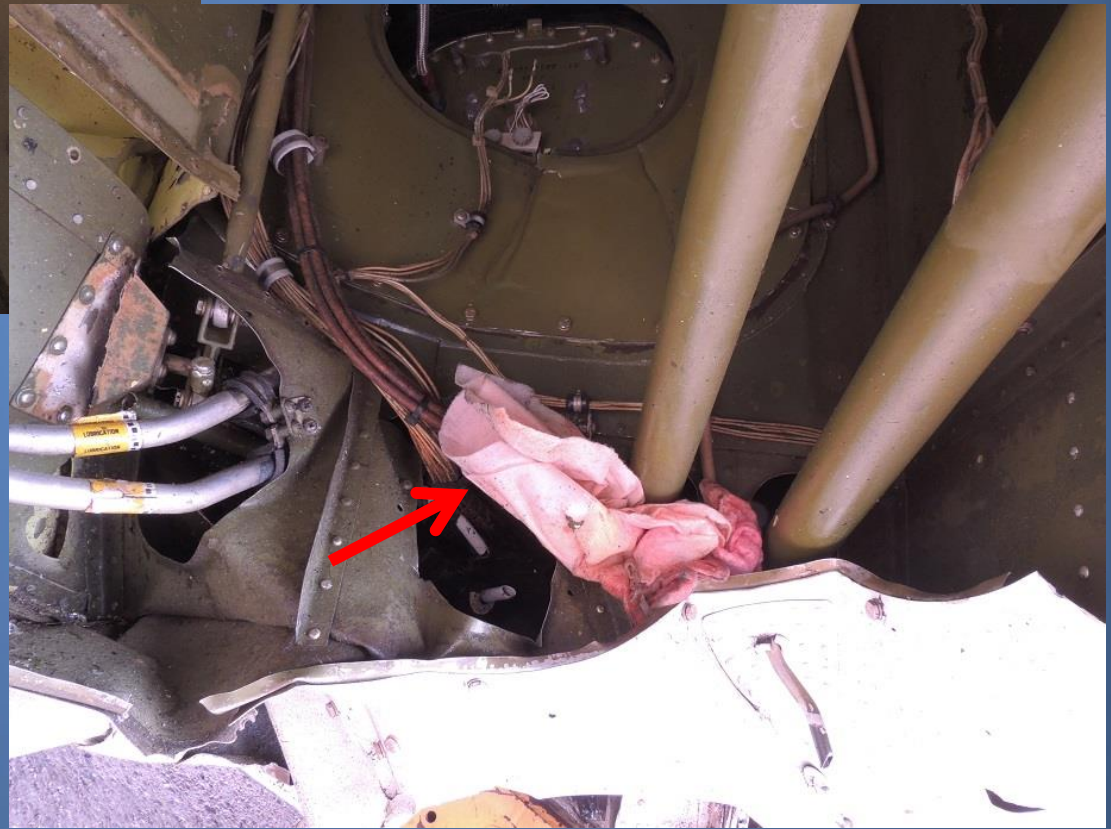
- All major components accounted for on scene.
- Evidence of engine providing power at the time of the accident.
- Hydraulic check valve in the area of undistorted aft belly compartment structure could be rotated by hand. Several rags soaked with hydraulic fluid found in the same compartment.
- Bulb filament analysis revealed hydraulic pressure annunciator and auxiliary master caution lights exhibited evidence of stretching. Remainder of annunciator bulbs did not appear stretched.

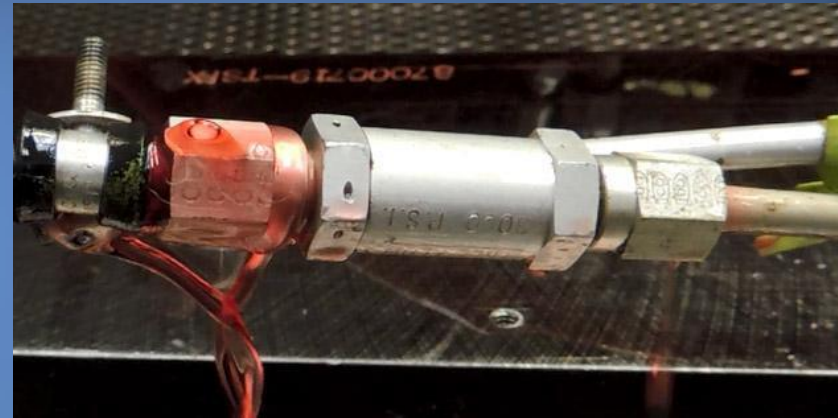
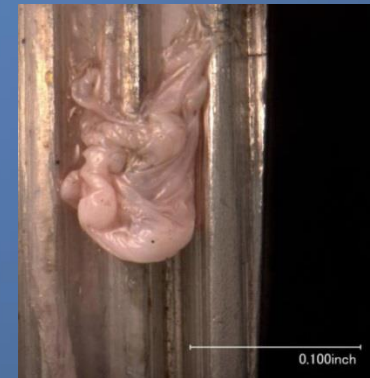
- Bench testing of check valve revealed a severe hydraulic leak.
- Bunched teflon [tape] found on outlet threads of check valve.
- Stress corrosion cracks found on both inlet and outlet ends of check valve.

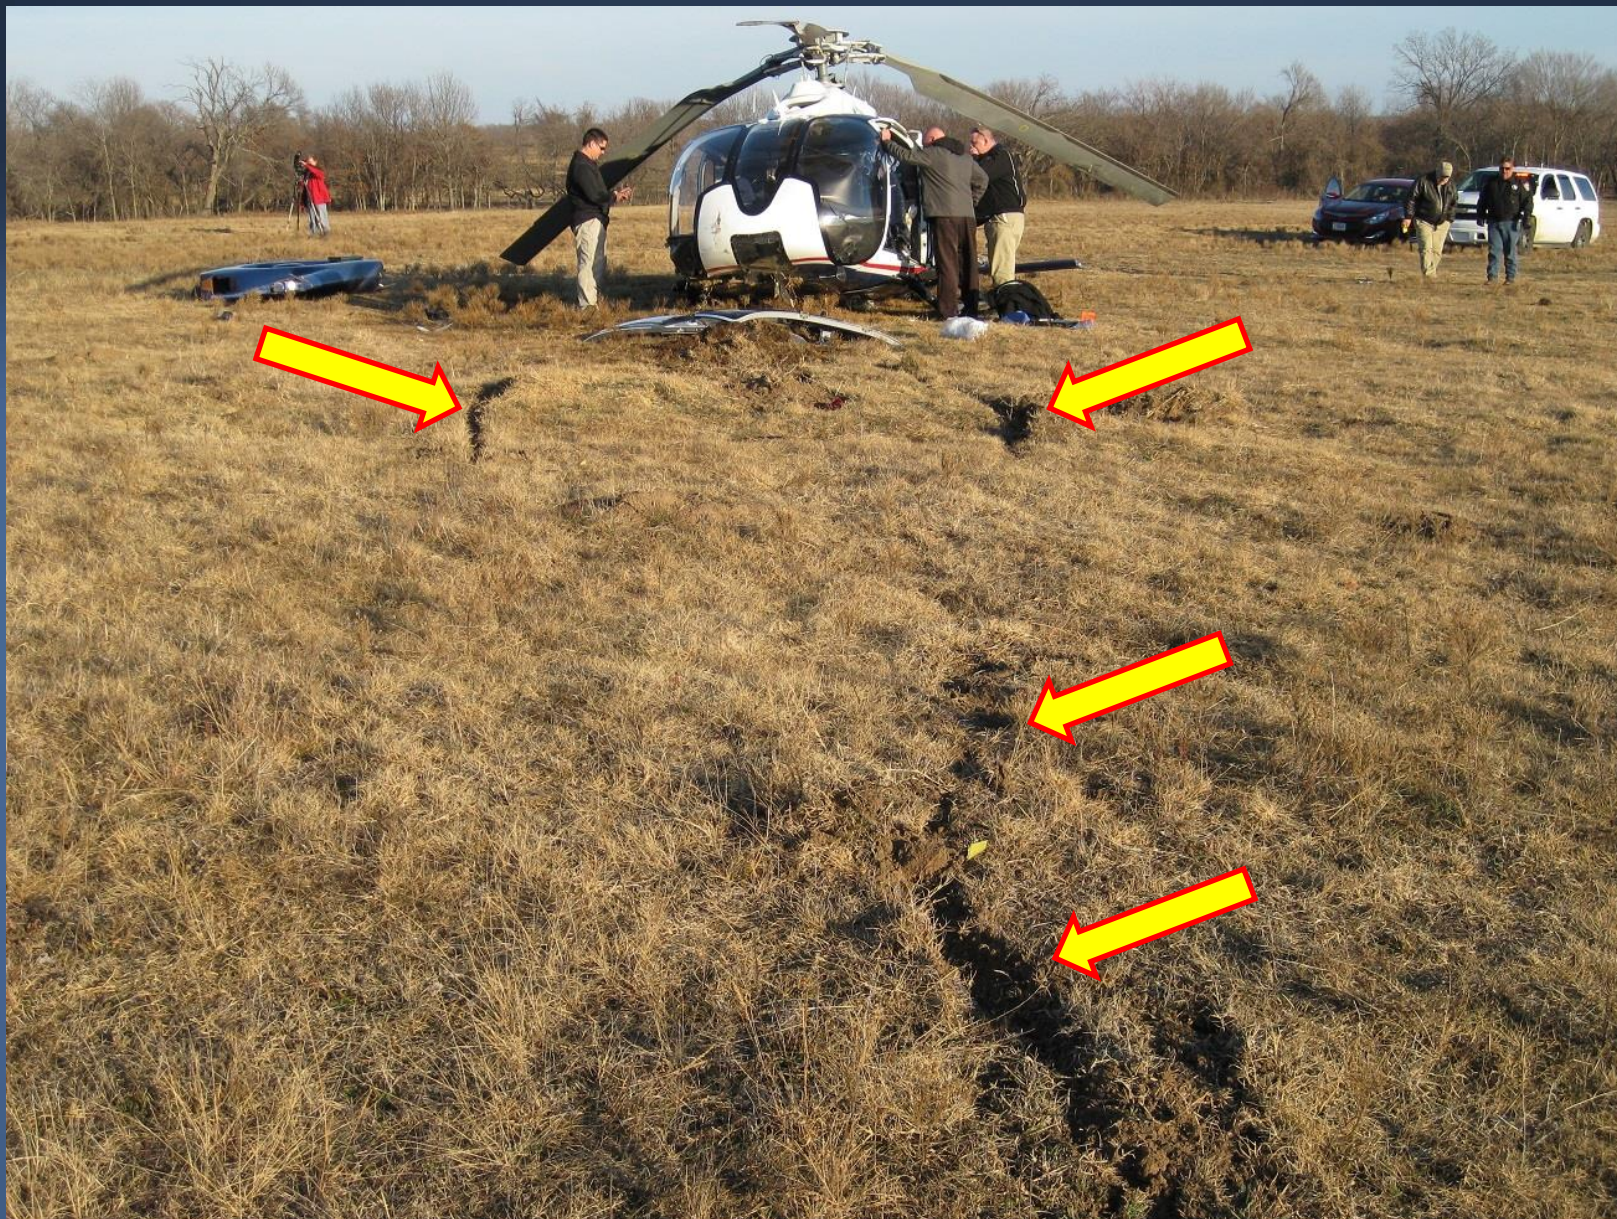
- Ground scars consistent with helicopter rotating about 180° from initial ground impact to resting position.
- All major helicopter components were accounted for at the accident scene.
- Main rotor blades exhibited signatures consistent with low rotational energy at ground impact.

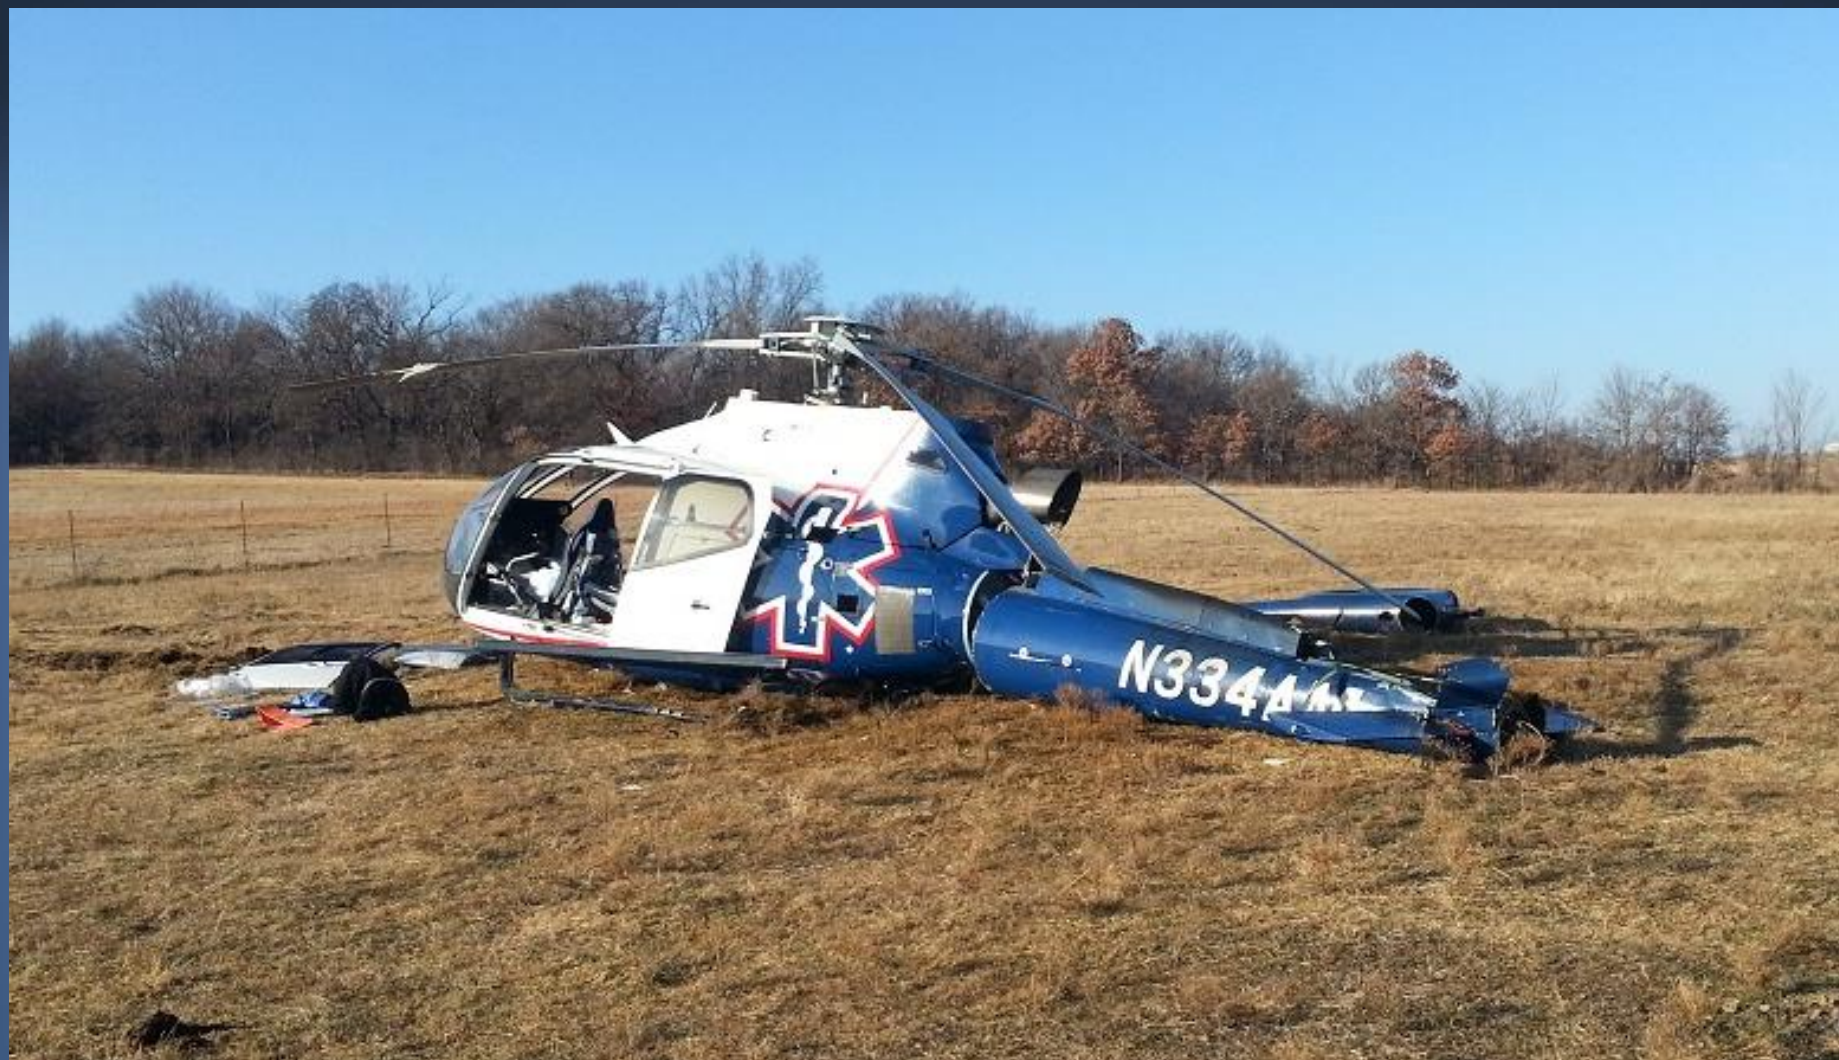
- Engine cowlings were found in the closed position with no evidence of abnormal damage.
- Air filter showed no evidence of damage.
- No blockages or large pieces of debris found on either side of air filter.
- Air intake duct drain hole showed no evidence of blockages.
- Engine remained installed on the airframe.
